# A collection of South African aircraft accidents and incidents

## “RIETBOK” Air Accident

Electronic Scanned Version  
Of The Actual Final Report

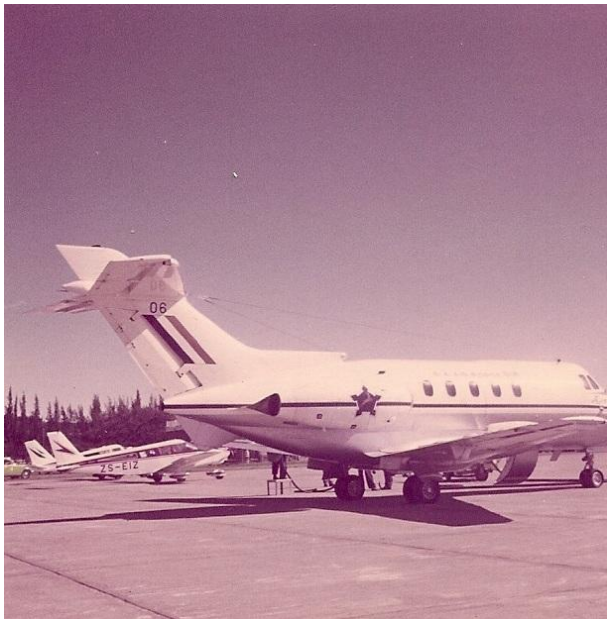
The mountain was shrouded in mist and low cloud. It is believed the pilot of the lead aircraft most probably miscalculated the arc of its turning circle coming from the direction of the Athlone cooling towers. The lead pilot's error in judgement meant the other two tragically followed it into the mountain with the loss of all three. The impact was heard throughout the surrounding suburbs. The accident meant that only one HS-125 Mercurius remained in the fleet (Dickens 2015). The three lost aircraft, with SAAF serial numbers 01, 02 and 03, were replaced in 1972, although not the serial numbers. The replacement aircraft became 05, 06 and 07. Number 06 (left) was photographed by me in Durban circa later 1970s. A 5th aircraft was added in 1983, numbered 08.

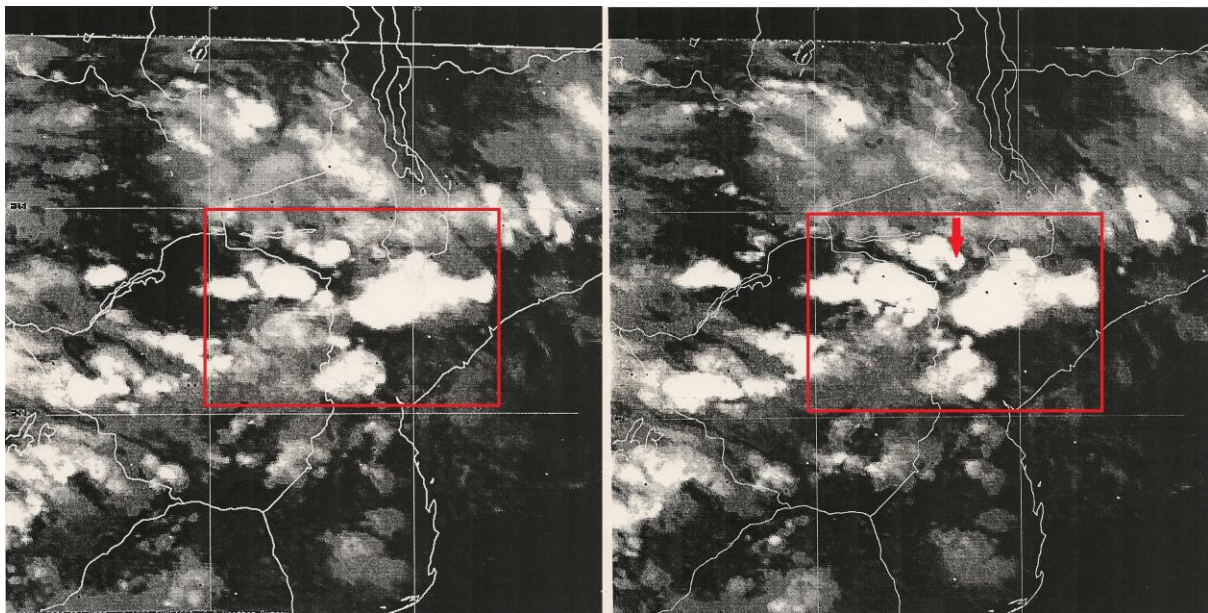
However, comparison of the two satellite images on the next page at 1600Z and 1630Z shows enlargement of two large thunderstorm anvils in the area of the incident over northern Zimbabwe with a smaller cell to the north of the large western cell. Significantly, development of a new small cell is evident on the eastern edge of this smaller cell, marked with a red arrow on the image on the right. Clearly the aircraft was flying toward an area of developing thunderstorm activity.

From the weather conditions discussed above and the report in the You magazine, where thunderstorm activity and prior turbulence is mentioned, it is believed that the severe turbulence was not caused when passing between the two large anvil areas, but suddenly a little time later there was severe turbulence near a thunderstorm top (TNTT) (Lester 1993) caused by the smaller developing cell.

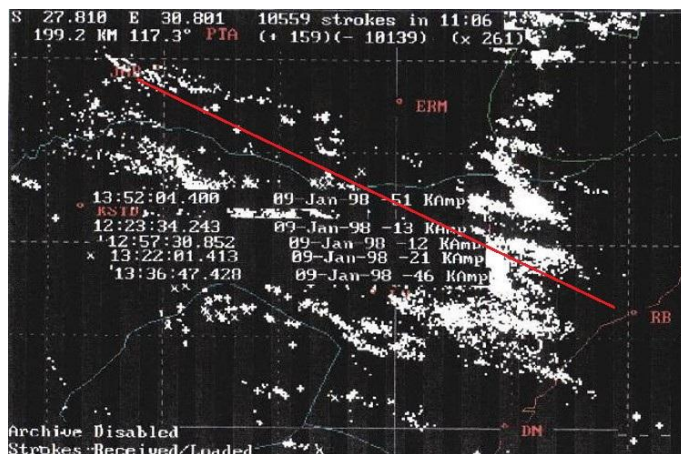
At the time, from 1993, Eskom, the South African Electricity Supply Commission, operated a network known as the Lightning Position and Tracking System (LPATS). This real time data and archived data was available to the SAWB. The LPATS map clearly indicates extensive lightning activity where the red track passes through in the Vryheid area. Individual flashes have been highlighted at times ranging from 12:24 to 13:52 SAST at the Vryheid

location 27.8°S 30.8°E shown in the top left corner of the figure. In a total of 11.6 hours the figure captured 10559 strokes, 10139 negative (-ve) and 159 positive (+ve) strokes. Negative lightning it is the transfer of -ve charge from the lower part of the cloud to the ground. Positive strokes, so called because there is a net transfer of +ve charge from the cloud to the ground, originate near top/upper part of the thunderstorm cloud. The descending stepped leader carries a positive charge, but the subsequent ground streamers are -ve charged. The +ve strokes are much less frequent than -ve strokes, because they must travel, or burn, through more air. However, for this reason +ve strokes are much stronger, cause a longer flash and a peak charge up to ten times stronger than a -ve stroke (NOAA). From October 2005 the South African Weather Service has owned and operated the Southern African Lightning Detection Network with complete national coverage from early 2006.

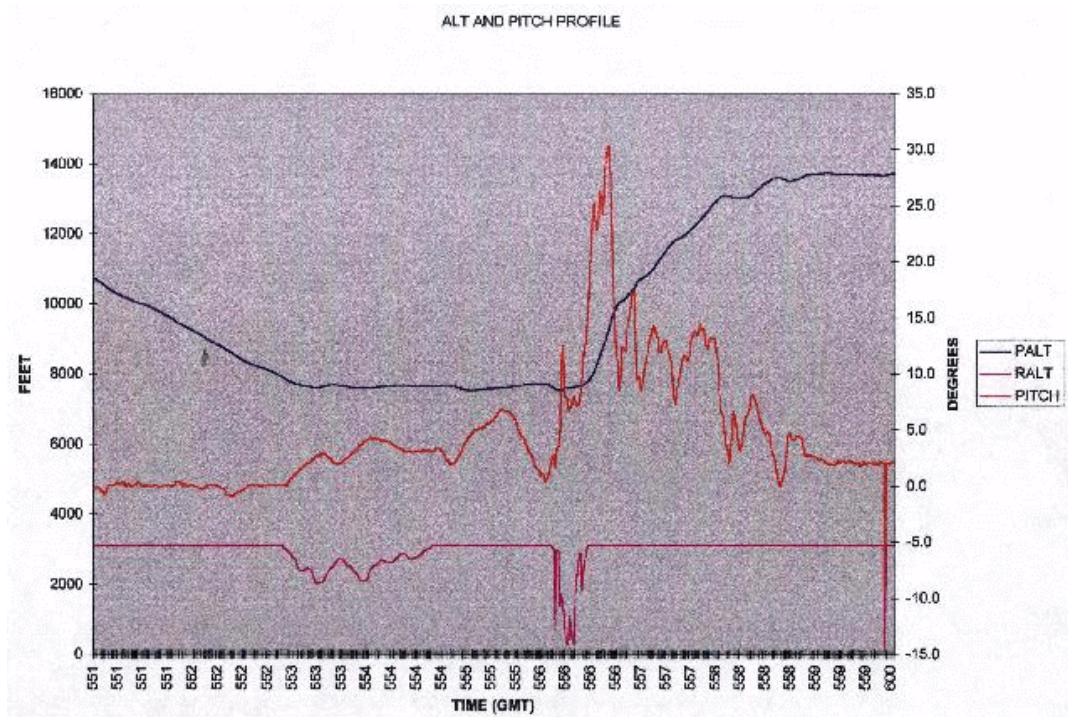
**Figure A.** Airbus A300 pressure altitude (top blue), pitch profile (middle red) and radio altimeter height (bottom mauve) from 0551Z to 0600Z 1998-10-08.

It would appear that the aircraft fell about 100ft in a downdraught and flew into a wall of rain. Whereupon the pilot reacted so strongly to the sight of the low radio altimeter height by applying such back pressure on the stick that it induced a temporary +1.8 G force. Temporary relaxation to about 7° pitch resulted in a drop in G force, but increase in pitch again to 30° caused increased G forces which at one time reached +1.6G. Later when the pitch was again decreased to about 7°, 0.1G was experienced (figures B and D).

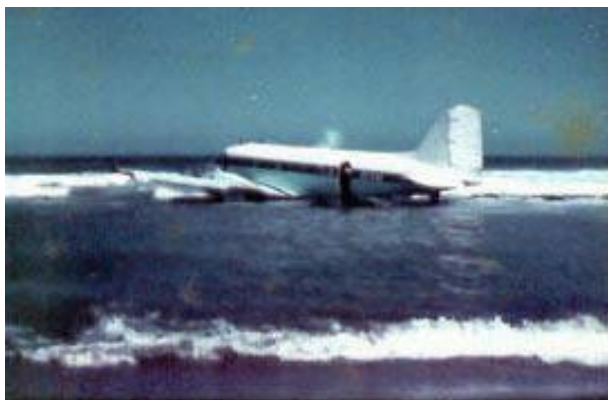
When I arrived, the chartered passenger Douglas C-49, registration ZS-DAK, was close inshore in shallow water caught on rocks. The 3 crew and 21 of the 22 passengers had already made it to shore and been taken away when I arrived. One passenger, a woman was never found, believed to have drowned and washed out to sea. I took some photographs of the aircraft stuck on rocks and left. The attached photograph was scanned from a slide photograph taken at the time.
