# A collection of South African aircraft accidents and incidents

## “RIETBOK” Air Accident

Electronic Scanned Version  
Of The Actual Final Report

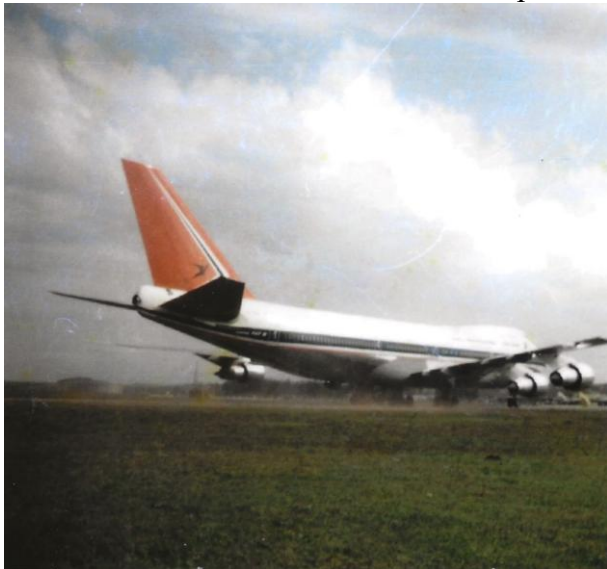
The author's stock photograph circa 1970s of a SAA B747-244B just landed at Durban with dust raised by the braking reverse thrust.
